# High Quality Insulation Installation Procedures (QII)

- Compliance credit for properly installed insulation
- Low-rise residential, wood frame buildings
- Available since 2005
- Will be used for 2008 compliance
- RA 3.5 For Fiberglass and Cellulose
- JA 7 For Spray Foam

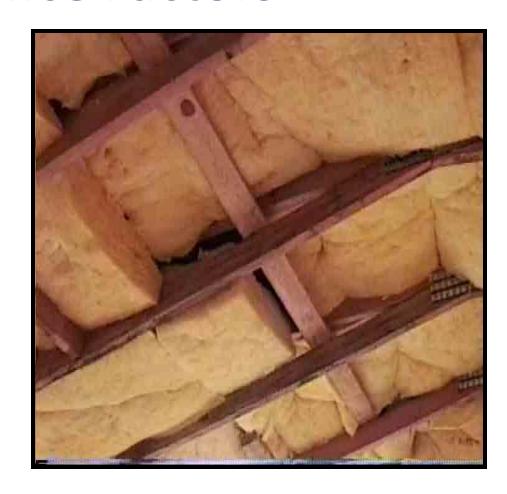
## Ceiling Insulation Performance Factors

- Continuous and air tight ceiling air barrier (usually the ceiling drywall)
- Insulation in contact with the air barrier
- No gaps or voids
- No compression

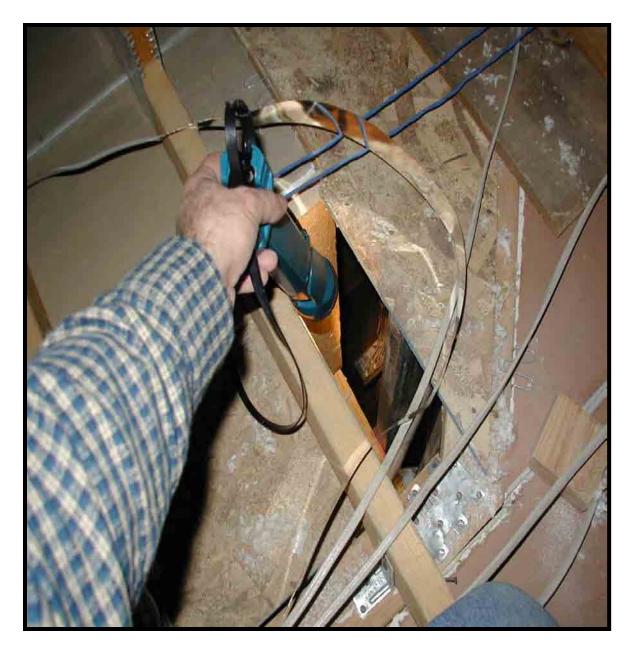
2. *Ceiling insulation*performance is dependant on a continuous air barrier.

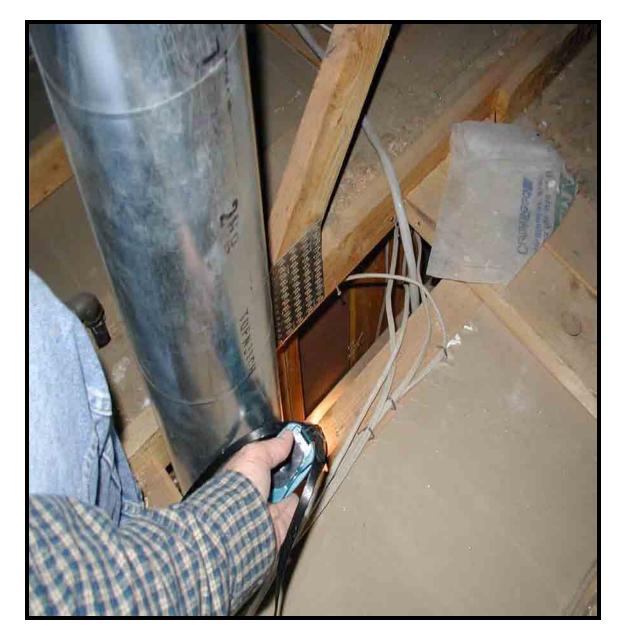
3. Fire Safety and Air Infiltration is dependent on an air tight Fire Stop (which also provides a continuous air barrier).

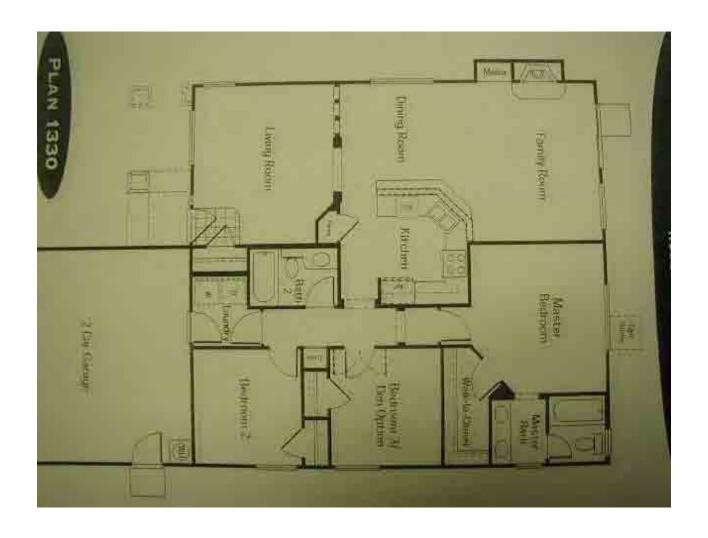
#### 5 problem areas show on the plans

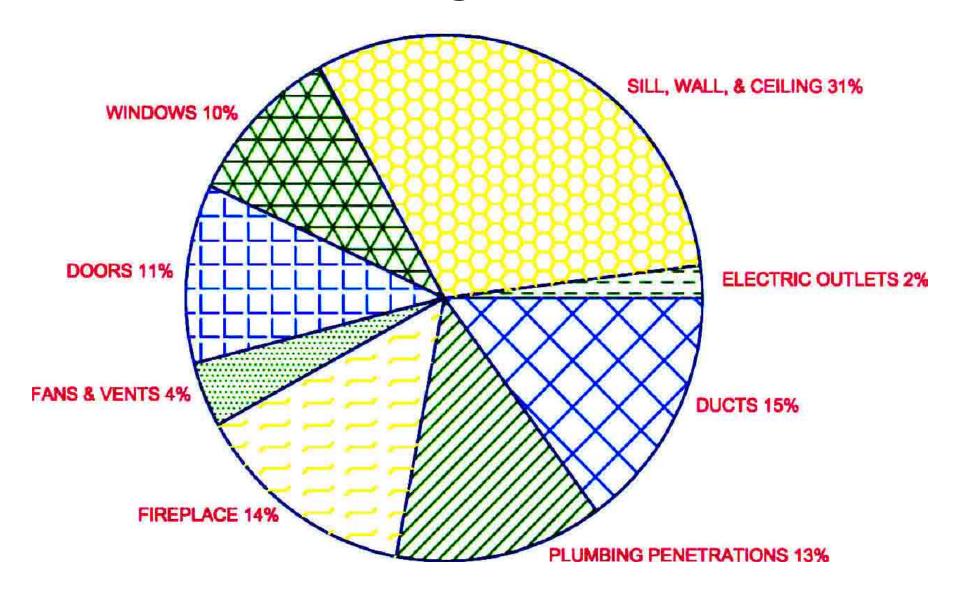
#### **Air Leakage Locations**

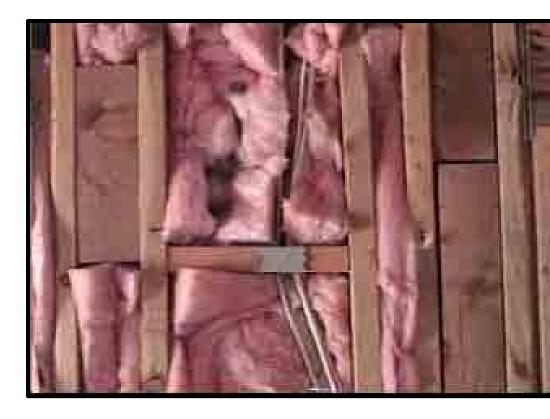
## Wall Insulation Performance Factors

- Substantially Air Tight Wall Cavity
- Insulation in contact with the air barriers (in contact with all 6 sides of the cavity)
- No gaps or voids
- No compression

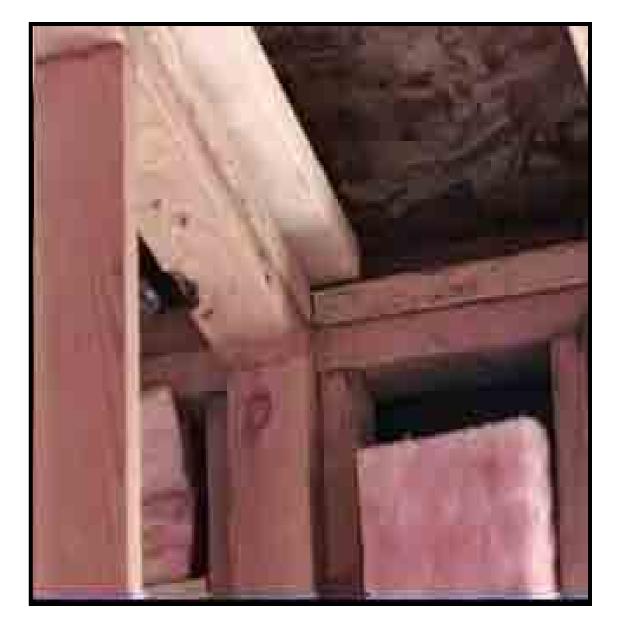
4. Wall Insulation
is very hard to
install at its full,
laboratory rated,
performance
level.

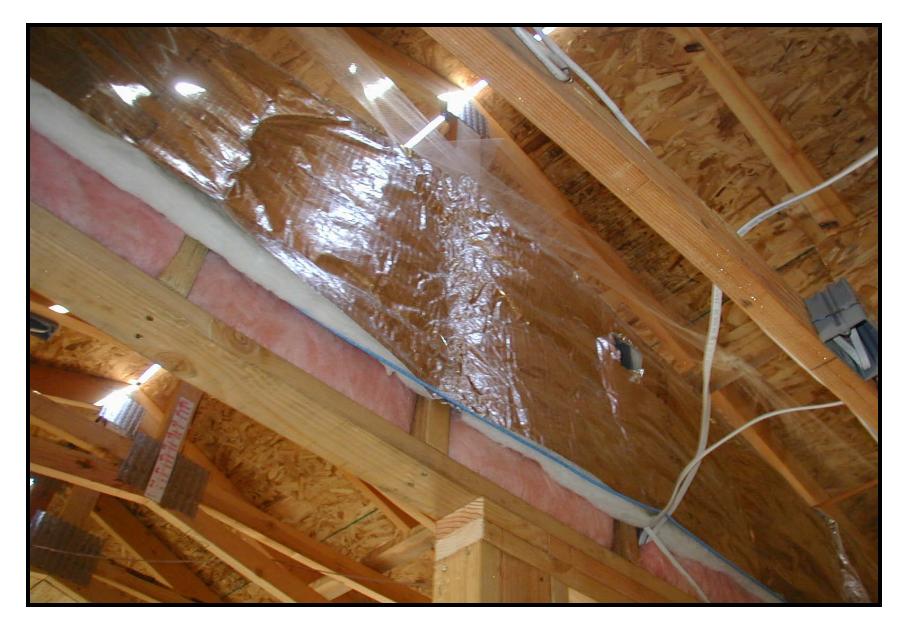
#### **Attic Kneewall Demonstration**

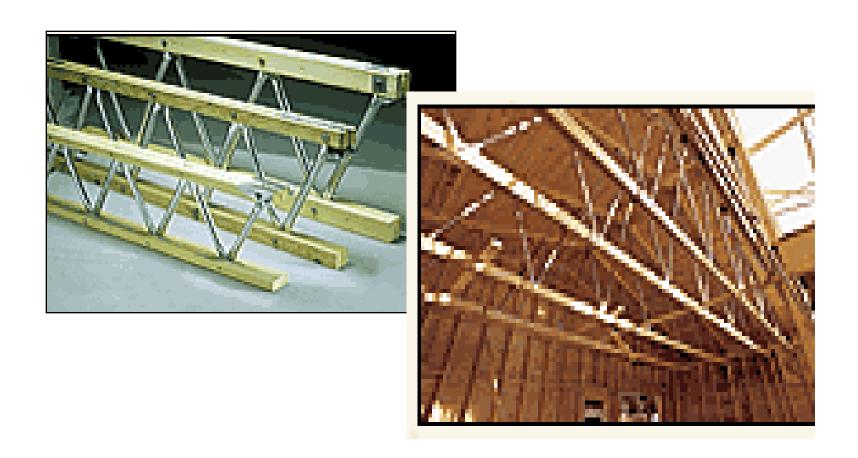
### Open Web Trusses

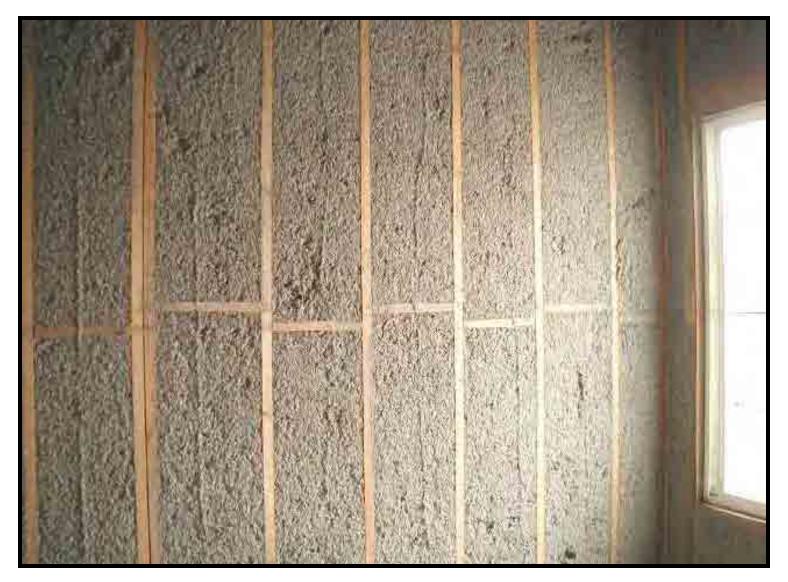
R-15 is specified – but what is the performance?

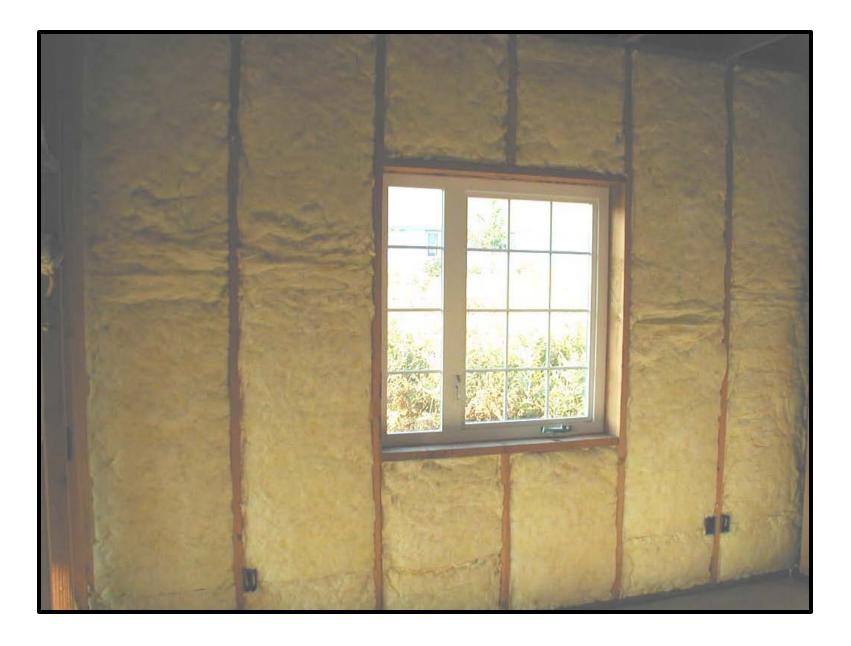
R-12 is specified – what is the performance?
